Manhole Inspection Summary

Manhole # S33OO1008MH

Insp Date: **4/20/07 5:13 AM**

Location Address: **4501 CHARLES ST**

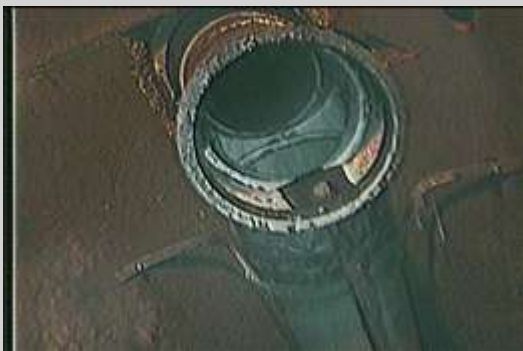
8 in. Circular Gravity Sewer Pipe In @ 6 O'Clock

Pipe Material: **PVC** ☐ Pipe Lined

Invert Depth: **5.90** (ft.) Flow Characteristics: **None**

Deposits: ☒ None ☐ Mud ☐ Sludge ☐ Debris ☐ Grease

Infiltration: **None** Pipe Seal Cond: **Unknown**

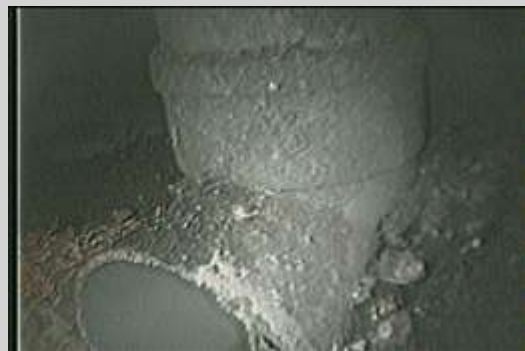
Drop In @ 6 O'Clock

Drop: **Inside**

Drop Condition: **Open**
